Grazing Management and Watershed Protection Plan

Lake Del Valle Property

Alameda County, California

January 5, 2015

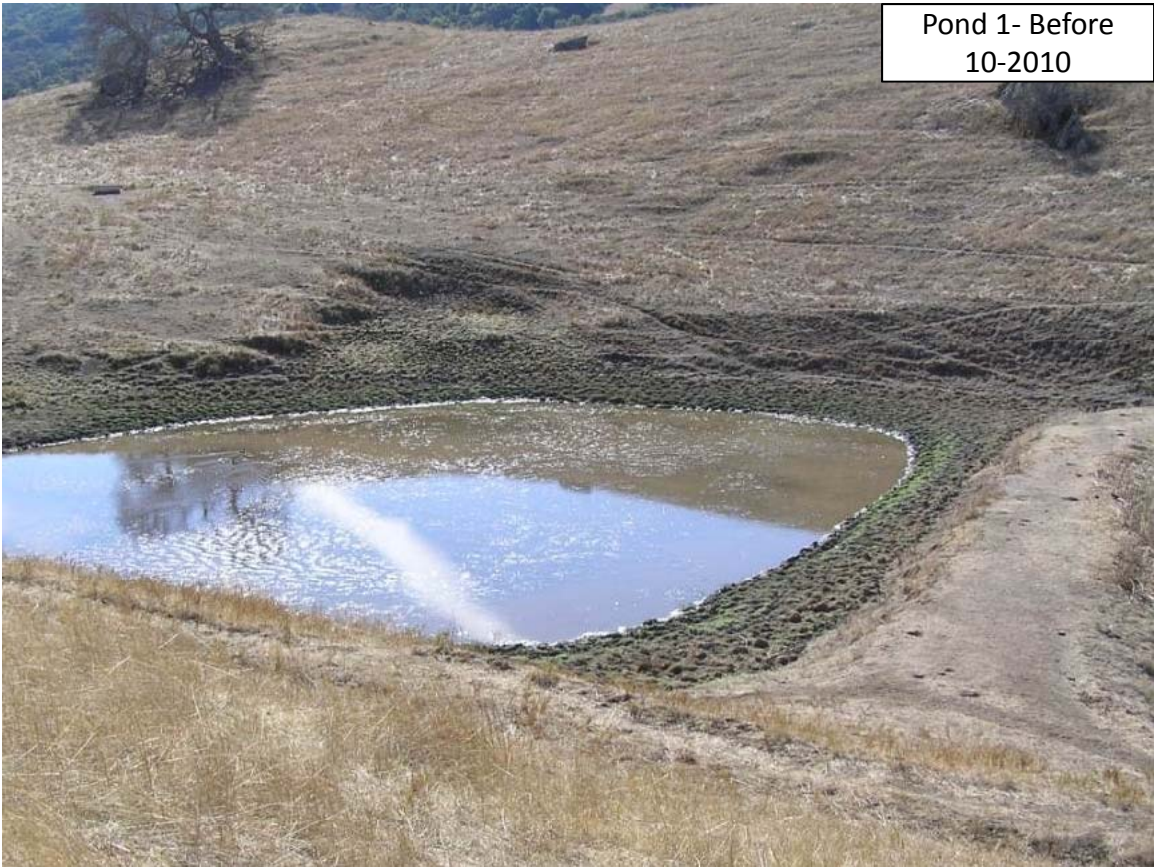
Pond 1- Before
10-2010

Pond 1 involved the removal of approximately 2000 cubic yards of sediment. The pond depth was returned to its original capacity (approximately 12 feet deep). The sediment disposal area was the existing corral area approximately 900 LF from the pond. Species that were found and/or relocated during construction included:

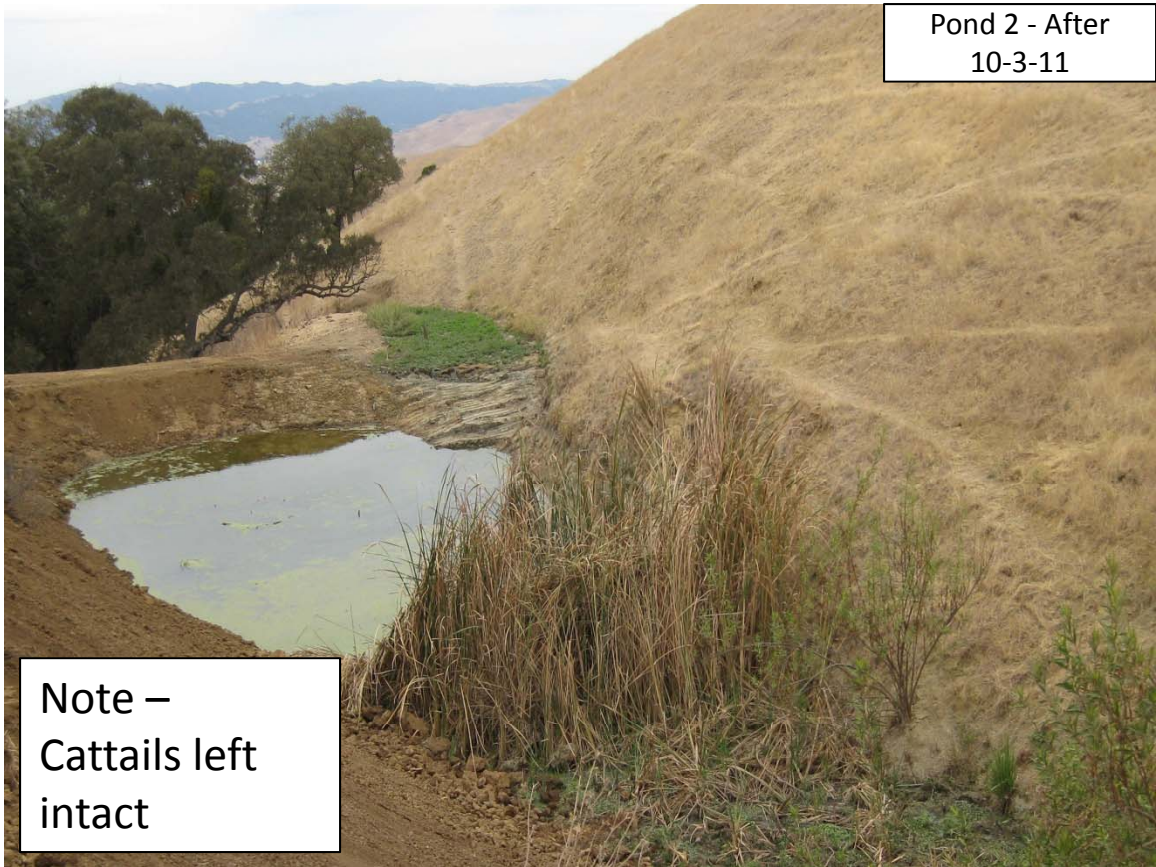
Pond 2 - After
10-3-11

Note –
Cattails left
intact

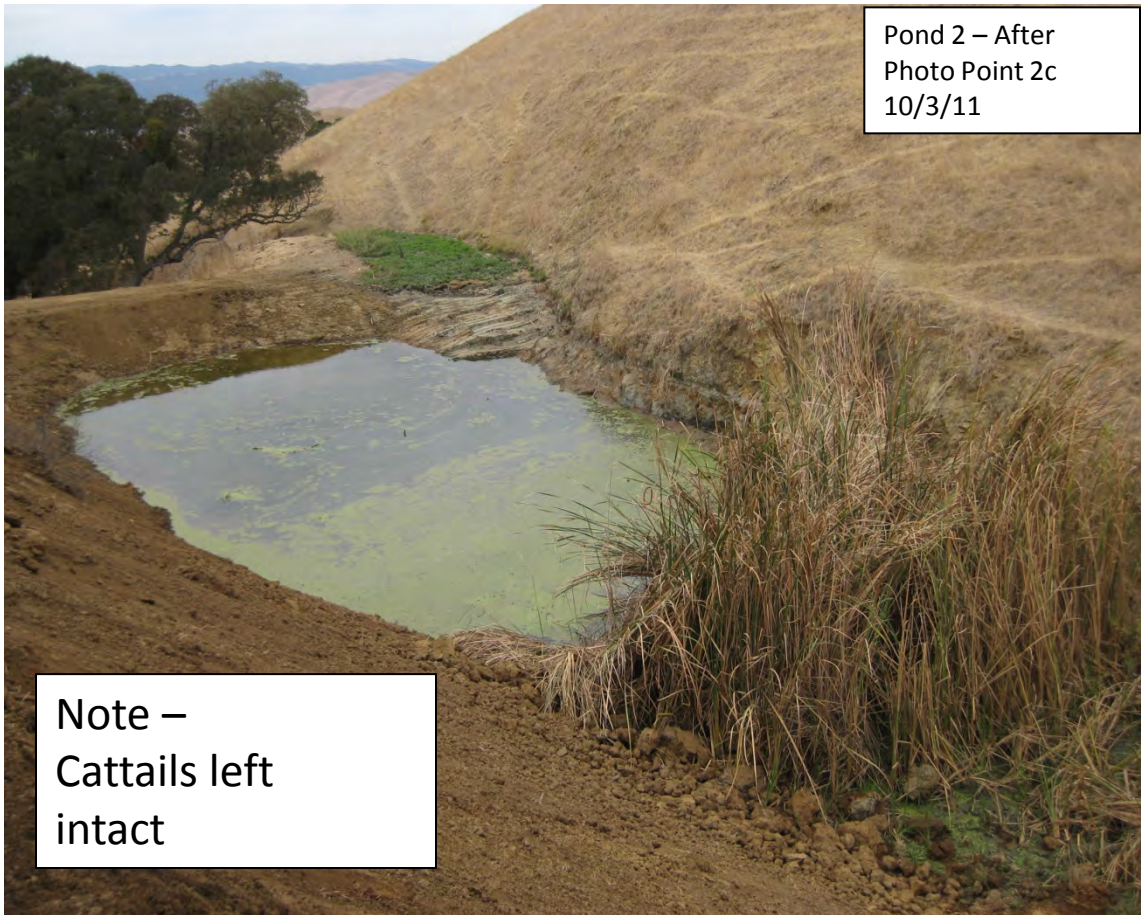
Pond 2 – After
Photo Point 2c
10/3/11

Note –
Cattails left
intact

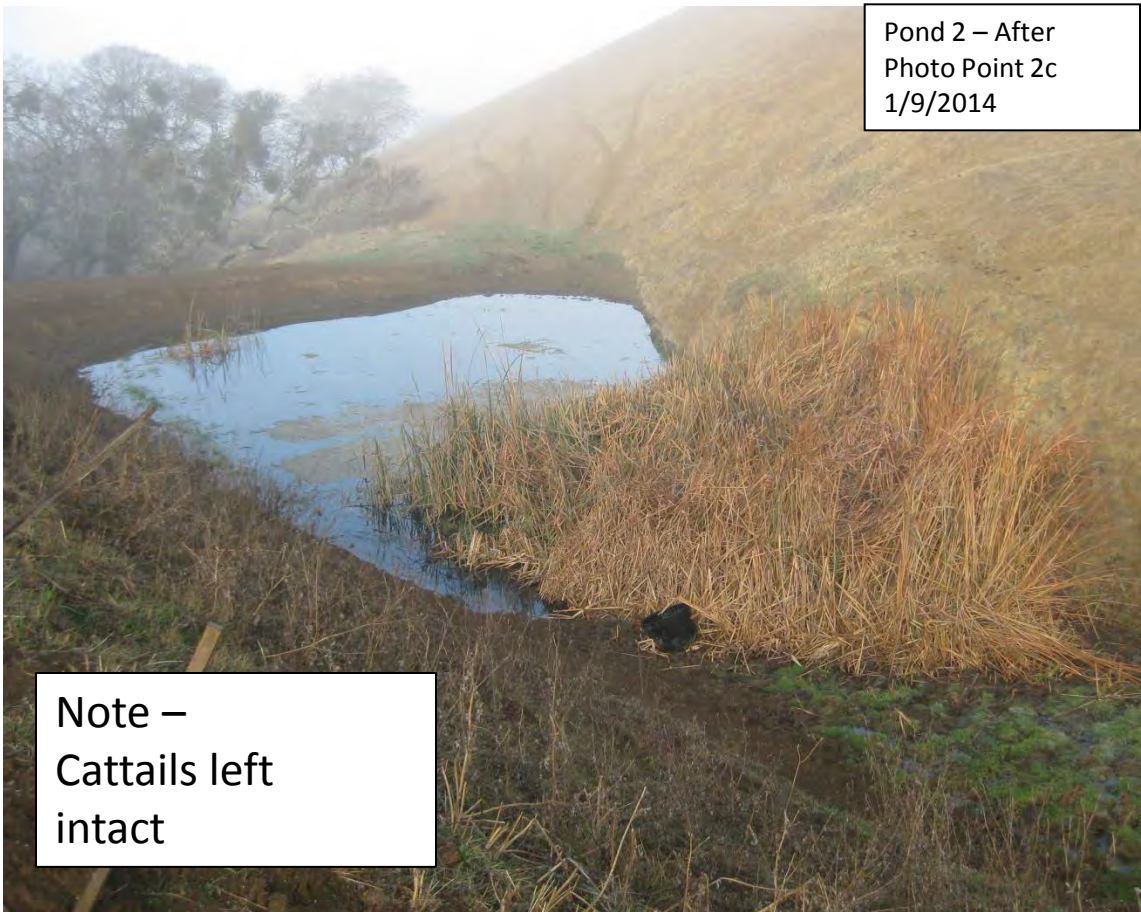
Pond 2 – After
Photo Point 2c
1/9/2014

Note –
Cattails left
intact

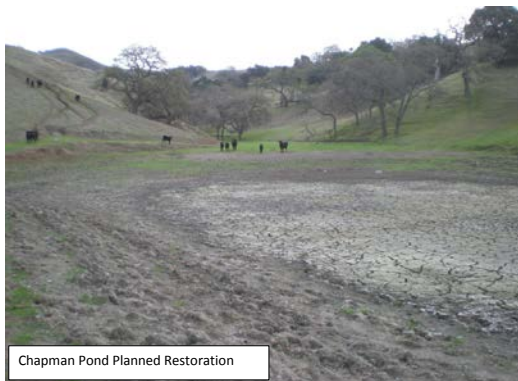
Chapman Pond Planned Restoration

NRCS Application #	Practice Code	Practice Name	Units	Amount	Year	Status	NRCS Cost Share	Description
749104143DA	378	Desed (Difficult Excavation), embankment pond with pipe, >500CY	No.	1	2015	Pending	Pending	Chapman Pond - Desedimentation and Spillway repair for improving wildlife habitat and livestock water.
749104143DA	378	Desed (Difficult Excavation), embankment pond without pipe	No.	1	2015	Pending	Pending	Bullfield Pond - Desedimentation and Spillway repair for improving wildlife habitat and livestock water.
749104143DA	734	Wildlife structure (Turtle Rafts)	No.	2	2015	Pending	Pending	Turtle rafts for Turtle pond and Ridgefield pond to improve basking areas for Western pond turtle.
749104143DA	382	Fence	No.	Pending	2015	Pending	Pending	Fence around riparian inlet of Ridgefield pond to reduce sedimentation from animal trampling into the pond.

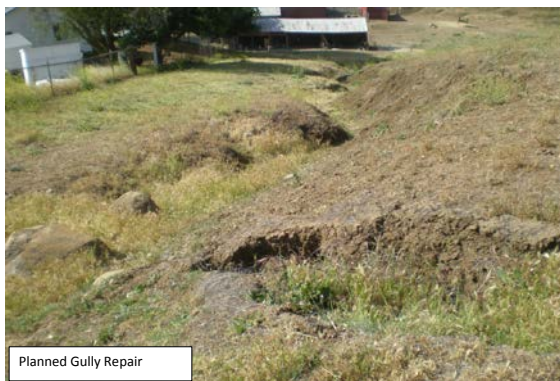
Planned Gully Repair

NRCS Contract #	Practice Code	Practice Name	Units	Amount	Year	Status	NRCS Cost Share	Description
799104105NP	382	Fence (Ft.)	ft	2,800	2014	Planned	\$8,955.00	Installation of cross-fencing as part of grazing management/improvement of livestock distribution.
799104105NP	468	Lined Waterway or Outlet (Ft.)	ft	375	2014	Planned	\$1,536.00	Gully repair to address erosion caused from road drainage.
799104105NP	468	Lined Waterway or Outlet (Ft.)	ft	10	2014	Planned	\$755.00	Gully repair to address erosion caused from road drainage.
799104105NP	468	Lined Waterway or Outlet (Ft.)	ft	60	2014	Planned	\$4,525.00	Gully repair to address erosion caused from road drainage.

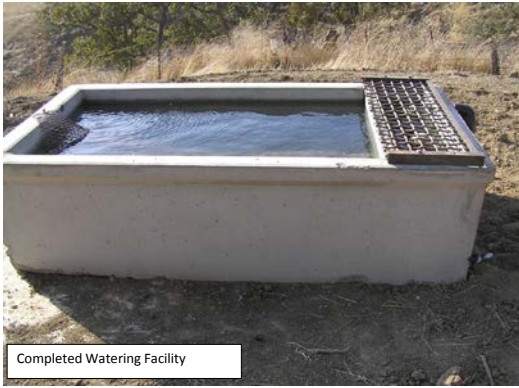
Completed Watering Facility

NRCS Contract #	Practice Code	Practice Name	Units	Amount	Year	Status	NRCS Cost Share	Description
799104105NP	614	Watering Facility (No.)	no	1	2010	Certified	\$1,134.00	Component of a livestock watering facility to support grazing management/improvement of livestock distribution.
799104105NP	614	Watering Facility (No.)	no	1	2010	Certified	\$2,610.00	Component of a livestock watering facility to support grazing management/improvement of livestock distribution.
799104105NP	382	Fence (Ft.)	ft	3,500	2012	Certified	\$23,732.10	Installation of cross-fencing as part of grazing management/improvement of livestock distribution.
799104105NP	382	Fence (Ft.)	ft	300	2010	Certified	\$959.46	Installation of cross-fencing as part of grazing management/improvement of livestock distribution.
799104105NP	382	Fence (Ft.)	ft	4,400	2011	Certified	\$14,072.08	Installation of cross-fencing as part of grazing management/improvement of livestock distribution.

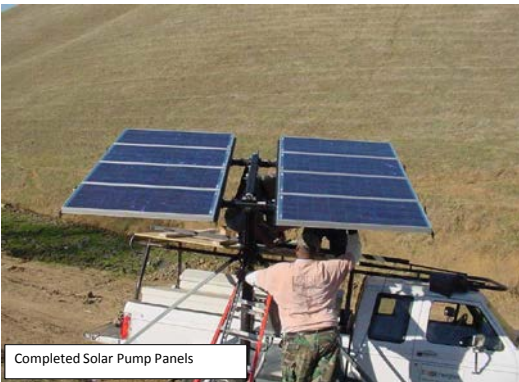
Completed Solar Pump Panels

NRCS Contract #	Practice Code	Practice Name	Units	Amount	Year	Status	NRCS Cost Share	Description
7491042A002	516	Pipeline (Ft)	ft.	1,250	2003	Certified	\$2,596.06	Component of a livestock watering facility to support grazing management/improvement of livestock distribution.
7491042A002	533	Pumping plant (No)	no.	1	2003	Certified	\$4,500.00	Component of a livestock watering facility to support grazing management/improvement of livestock distribution.
7491042A002	614	Watering facility (No)	no.	1	2003	Certified	\$1,700.00	Component of a livestock watering facility to support grazing management/improvement of livestock distribution.
7491042A002	614	Watering facility (No)	no.	4	2003	Certified	\$1,800.00	Component of a livestock watering facility to support grazing management/improvement of livestock distribution.
7491042A002	533	Pumping plant (No)	no.	1	2004	Certified	\$2,500.00	Component of a livestock watering facility to support grazing management/improvement of livestock distribution.

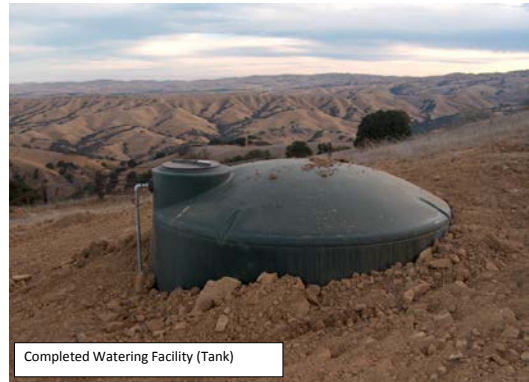
Completed Watering Facility (Tank)

7491042A002	574	Spring development (No)	no.	1	2004	Certified	\$2,238.00	Component of a livestock watering facility to support grazing management/improvement of livestock distribution.
7491042A002	516	Pipeline (Ft)	ft.	1,500	2005	Certified	\$3,750.00	Component of a livestock watering facility to support grazing management/improvement of livestock distribution.
7491042A002	614	Watering facility (No)	no.	2	2005	Certified	\$900.00	Component of a livestock watering facility to support grazing management/improvement of livestock distribution.
7491042A002	614	Watering facility (No)	no.	1	2005	Certified	\$1,750.00	Component of a livestock watering facility to support grazing management/improvement of livestock distribution.
