Subject PFAS Potential Source Investigation

Prepared for Zone 7 Water Agency

From Jacobs

Date December 4, 2020

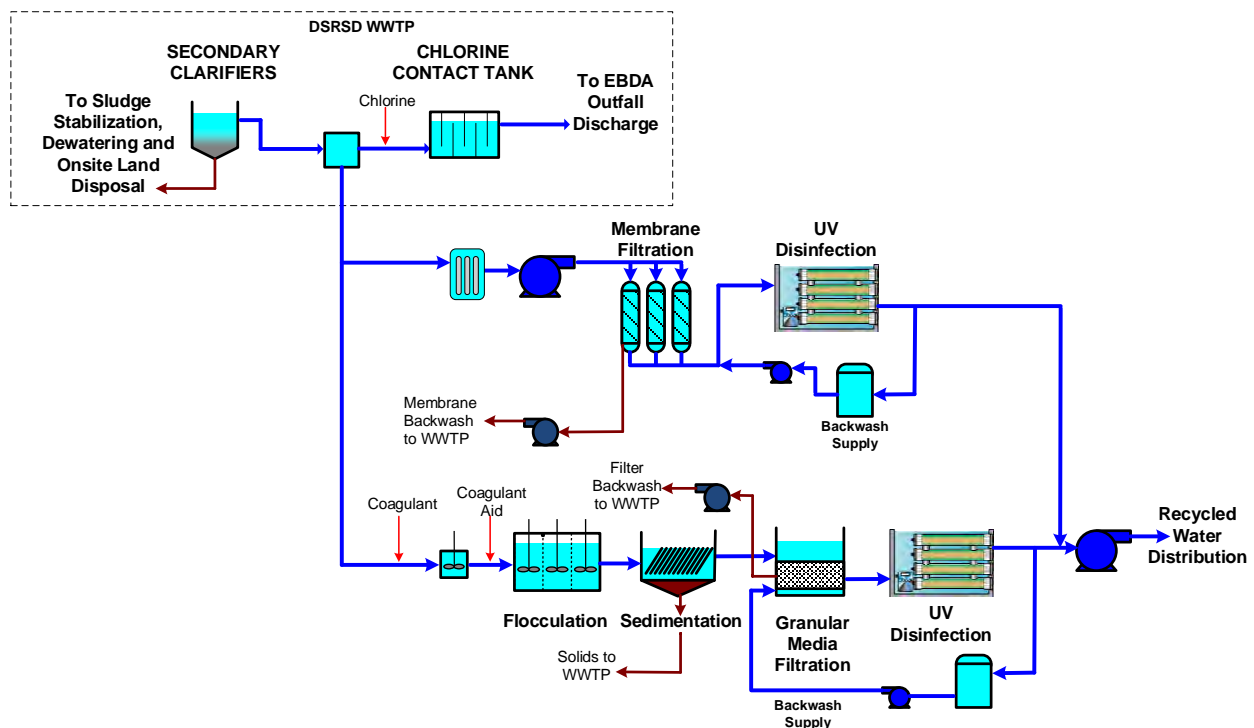
Exhibit 2. Process Flow Diagram of Recycled Water Treatment Facilities at DSRSD

The DSRSD regional WWTP produces disinfected tertiary recycled water that meets California Title 22 requirements. DSRSD and East Bay Municipal Utility District (EBMUD) work under a Joint Powers Agreement that formed the DSRSD/EBMUD Recycled Water Authority (DERWA). The tertiary recycled water facilities located at the DSRSD WWTP are owned and operated by DSRSD. The tertiary process uses coagulation, flocculation, sand filters, and ultraviolet (SF-UV) light disinfection to treat secondary effluent at flows between 2.5 to 9.7 mgd, during periods of high demand. Microfiltration combined with ultraviolet (MF-UV) light disinfection are used during periods of low demand, when daily demand falls below 2 mgd, mostly during the months of November to February. The MF-UV flow capacity is limited to 3 mgd. Exhibit 2 provides a process flow diagram of the recycled water treatment facilities at DSRSD.

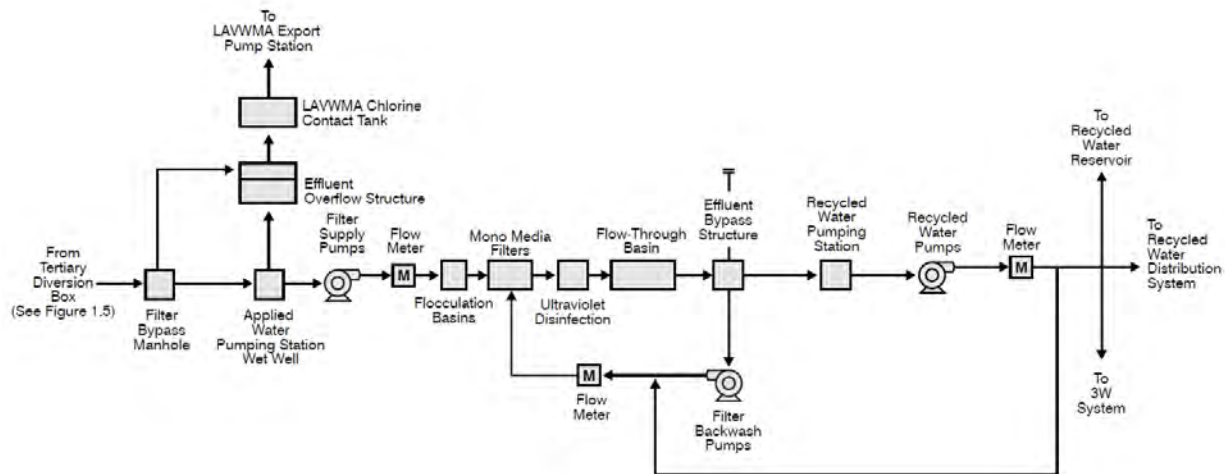
Exhibit 3. Tertiary Treatment Process Schematic for LWRP

tertiary treatment process schematic is shown in Exhibit 3. In addition to the secondary treatment train, a parallel treatment consists of pumping secondary effluent to two flocculation tanks where polymer is added before entering the deep bed granular media filters. Filtered water is then conveyed through the UV disinfection system. A maximum flow of recycled water available for unrestricted irrigation in the City of Pleasanton is approximately 1.7 mgd (maximum month basis).

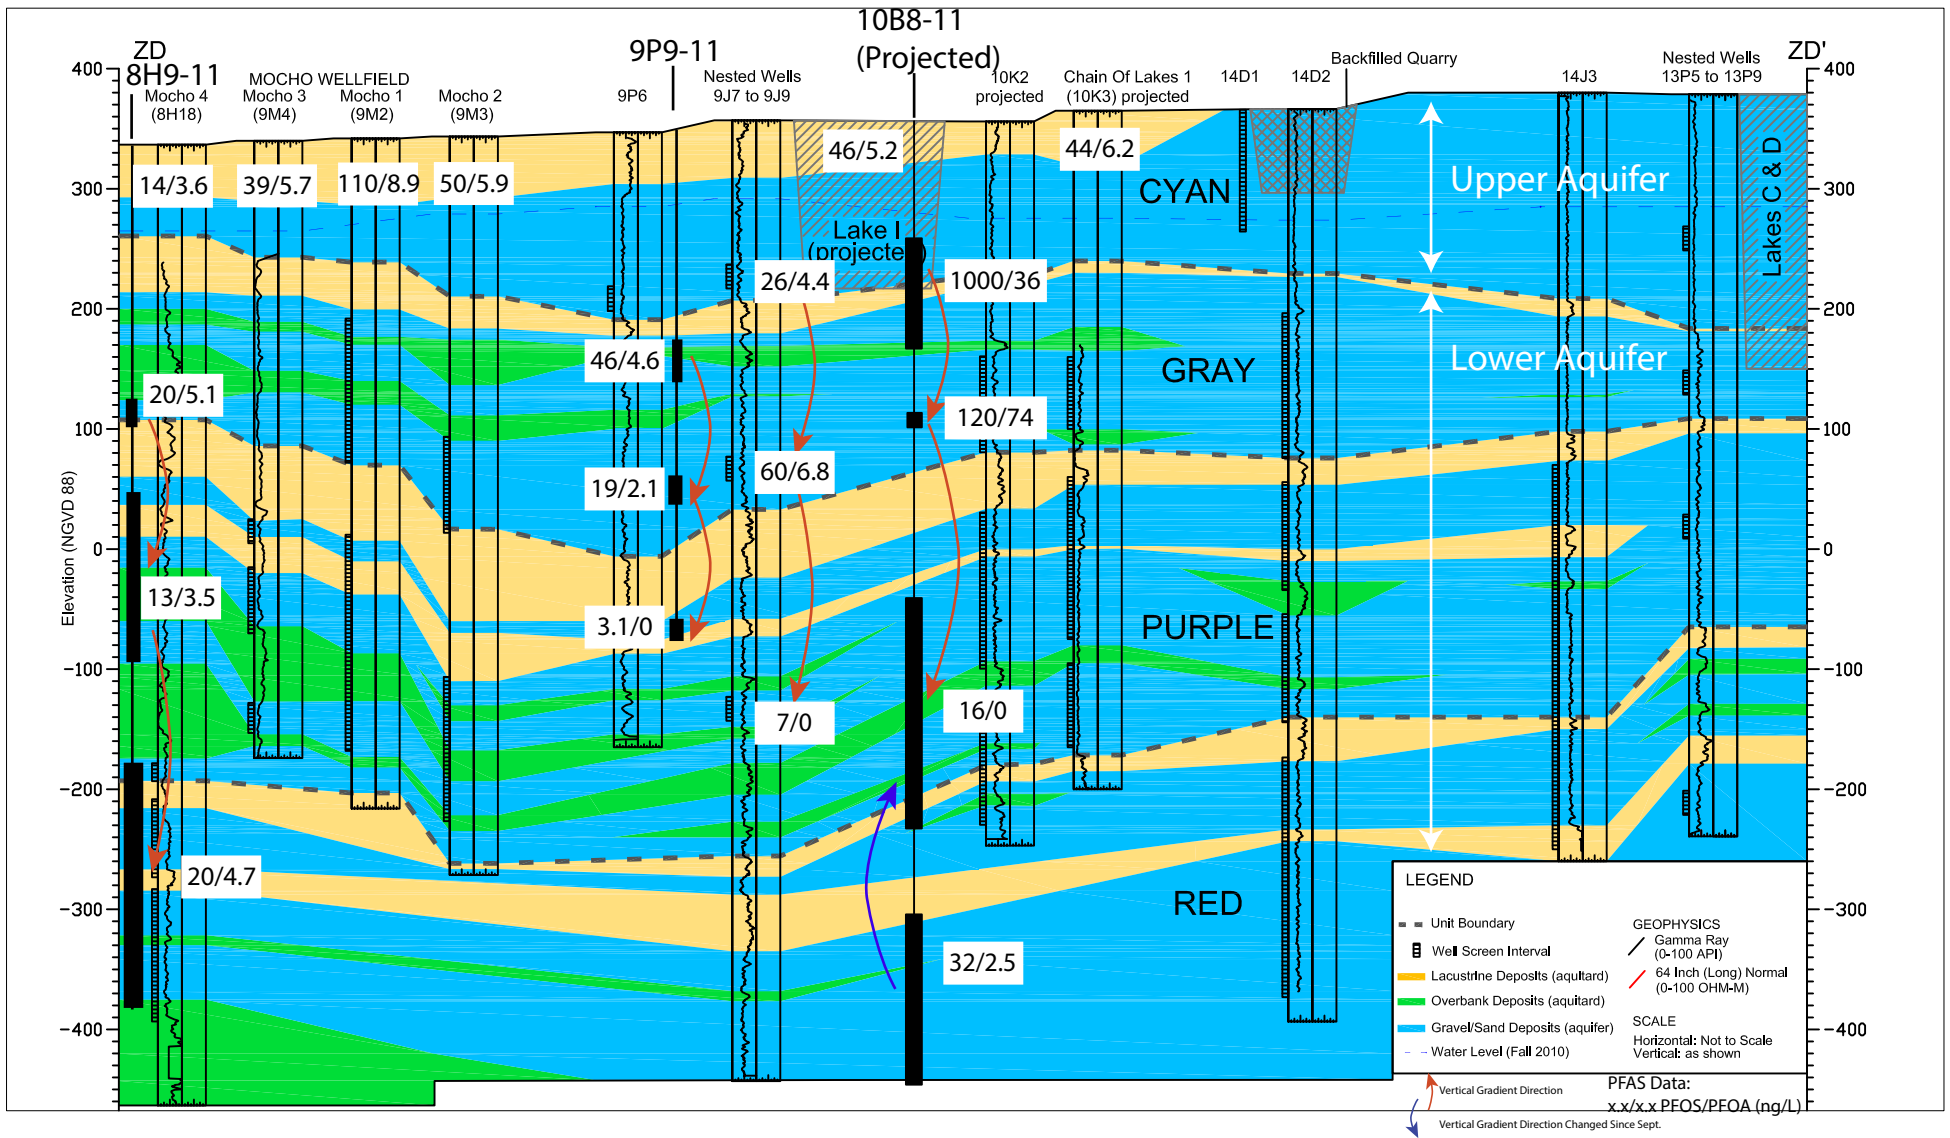
Cross Sections ZA to ZC

PROJECT:
Hydrostratigraphic Investigation
of the Aquifer Recharge Potential
For Lakes C and D
FIGURE NO.:
Attachment A-1

The difference in head observed between the Upper and Lower Aquifer indicates a degree of hydraulic separation. Vertical hydraulic gradients were calculated for nine multi-level monitoring wells, consisting of a total of 31 discrete monitoring depths, with groundwater level data to determine the vertical movement of groundwater between the Upper and Lower Aquifers, and within the Lower Aquifer. Water level data from the monitoring wells were compared in spring and fall. The direction of flow in each of the wells is shown on the geologic cross-sections in Attachments A-1 and A-2.
